**NIST NCSTAR 1-5A** Federal Building and Fire Safety Investigation of the World Trade Center Disaster

## Visual Evidence, Damage Estimates, **And Timeline Analysis**

(Appendices D-G)

## Appendix D WTC 1 EAST FACE COMBINED FIRE AND WINDOW CONDITION AND WINDOW SMOKE CONDITION

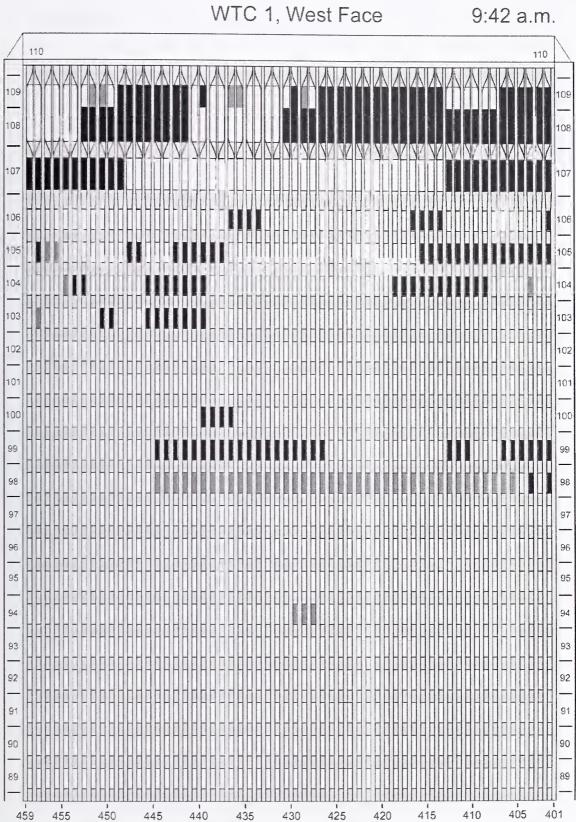
Figure F-40. Diagram of the west face of WTC 1 for floors 89 to 110 at 9:42 a.m. showing windows where smoke was observed and those that were hidden from view.

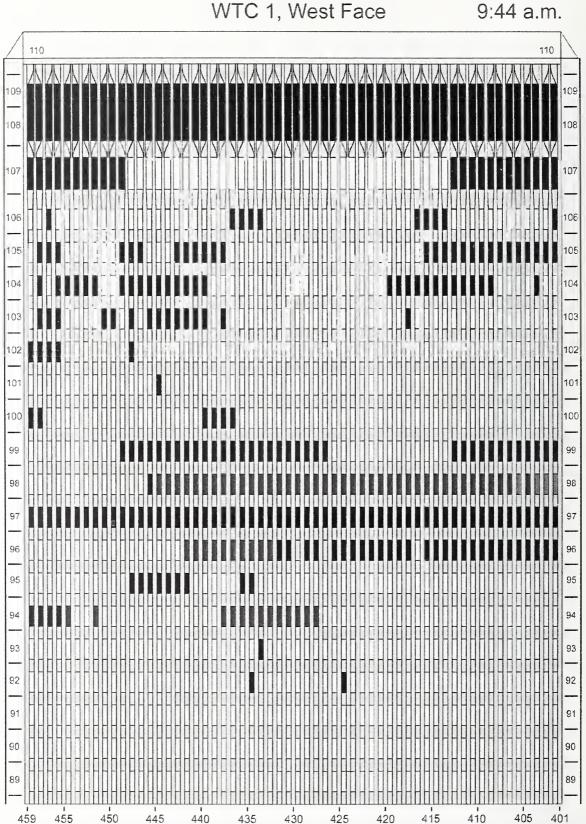
Figure F-41. Diagram of the west face of WTC 1 for floors 89 to 110 at 9:44 a.m. showing the condition of windows and locations of fires.

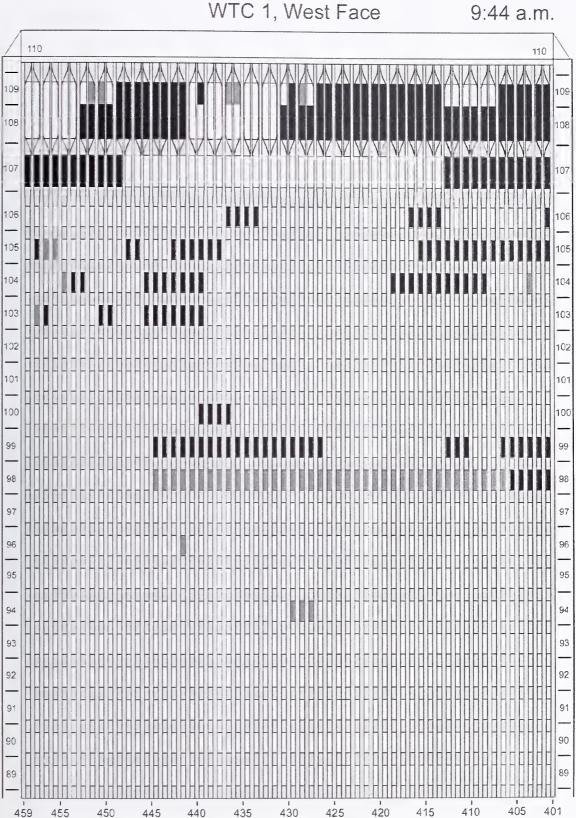
Figure F-42. Diagram of the west face of WTC 1 for floors 89 to 110 at 9:44 a.m. showing windows where smoke was observed and those that were hidden from view.

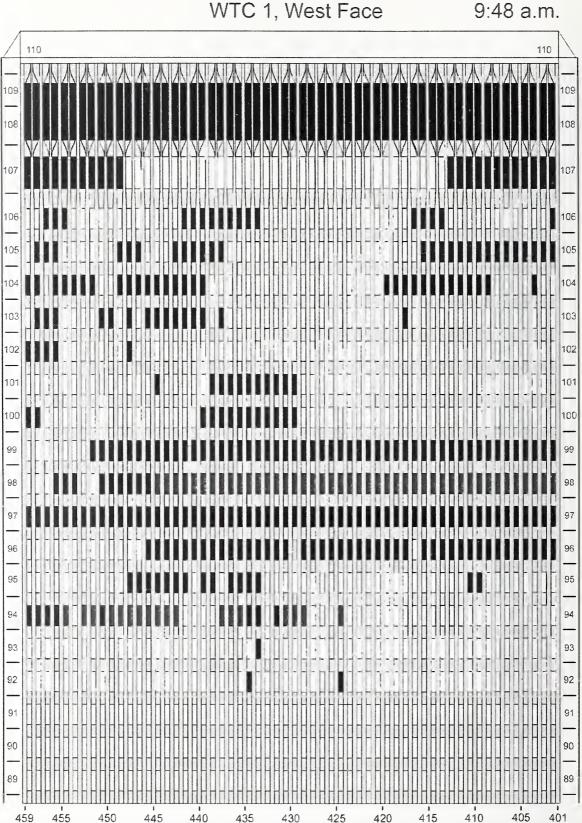
Figure F-43. Diagram of the west face of WTC 1 for floors 89 to 110 at 9:48 a.m. showing the condition of windows and locations of fires.

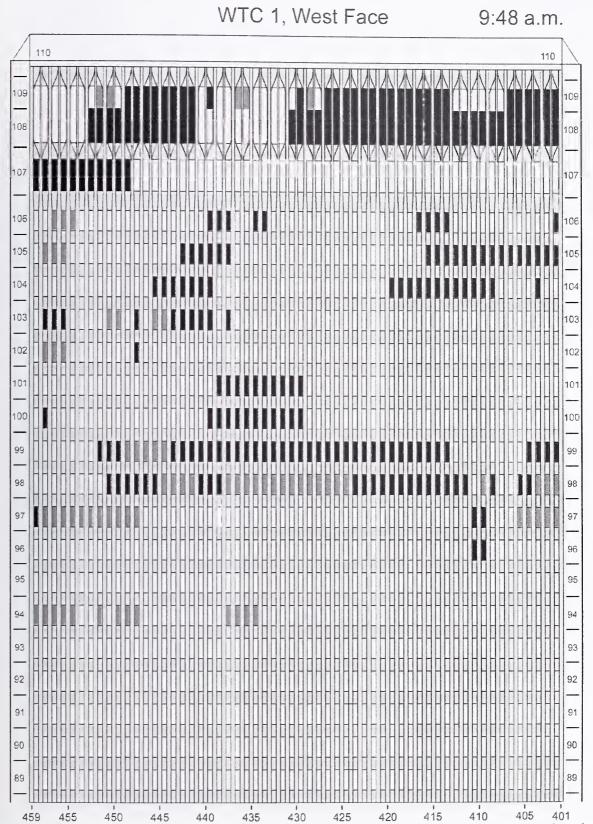
Figure F-44. Diagram of the west face of WTC 1 for floors 89 to 110 at 9:48 a.m. showing windows where smoke was observed and those that were hidden from view.

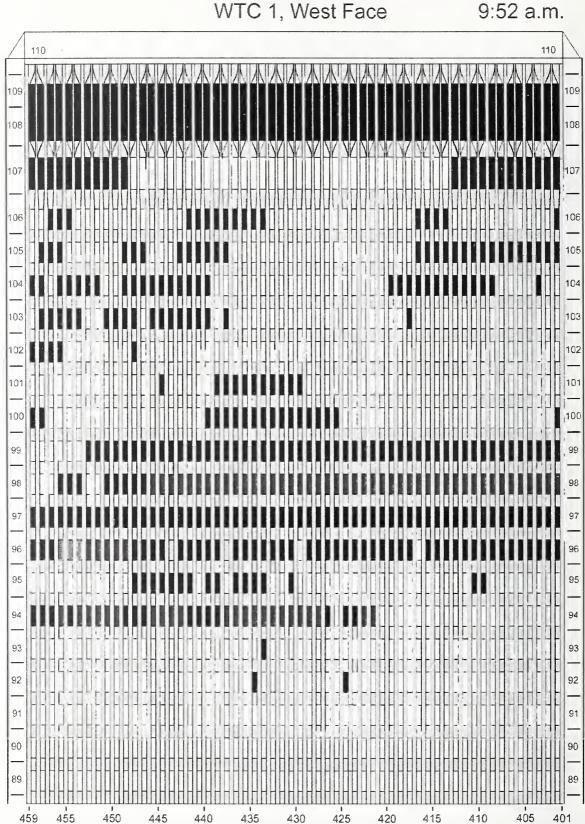
Figure F-45. Diagram of the west face of WTC 1 for floors 89 to 110 at 9:52 a.m. showing the condition of windows and locations of fires.

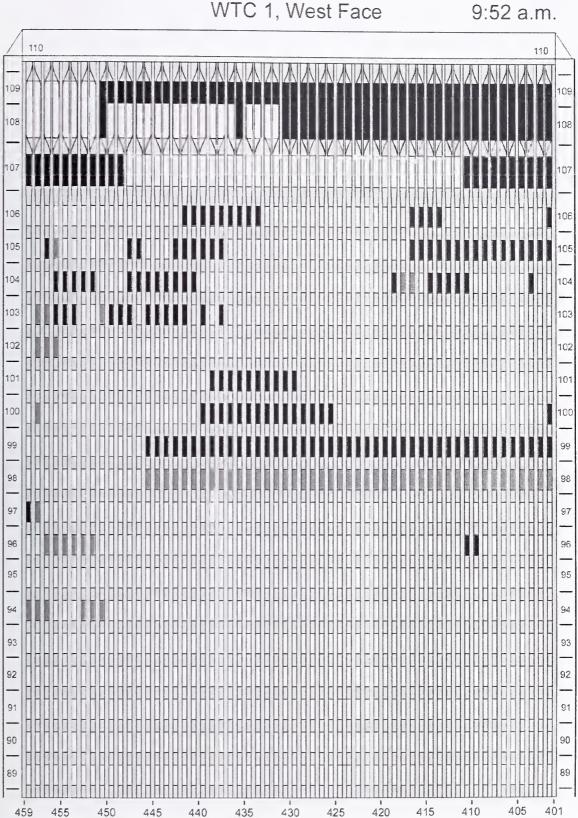
Figure F-46. Diagram of the west face of WTC 1 for floors 89 to 110 at 9:52 a.m. showing windows where smoke was observed and those that were hidden from view.

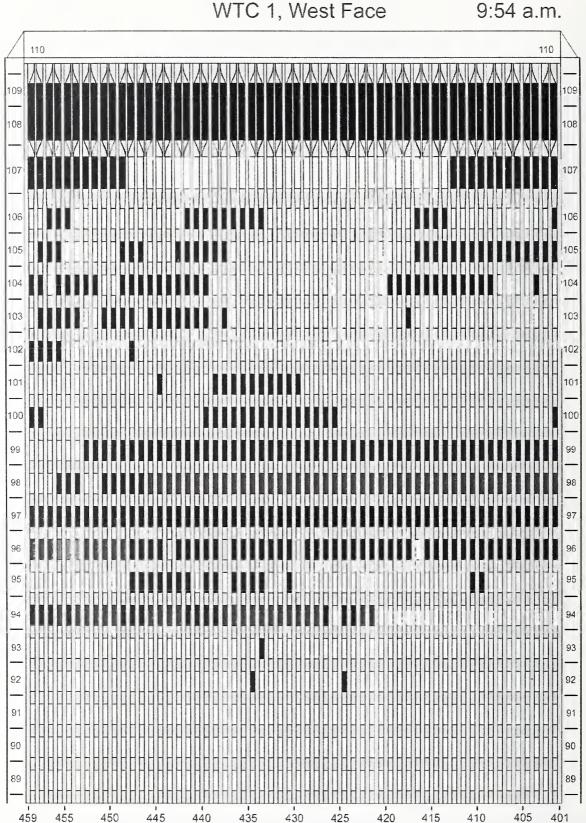
Figure F-47. Diagram of the west face of WTC 1 for floors 89 to 110 at 9:54 a.m. showing the condition of windows and locations of fires.

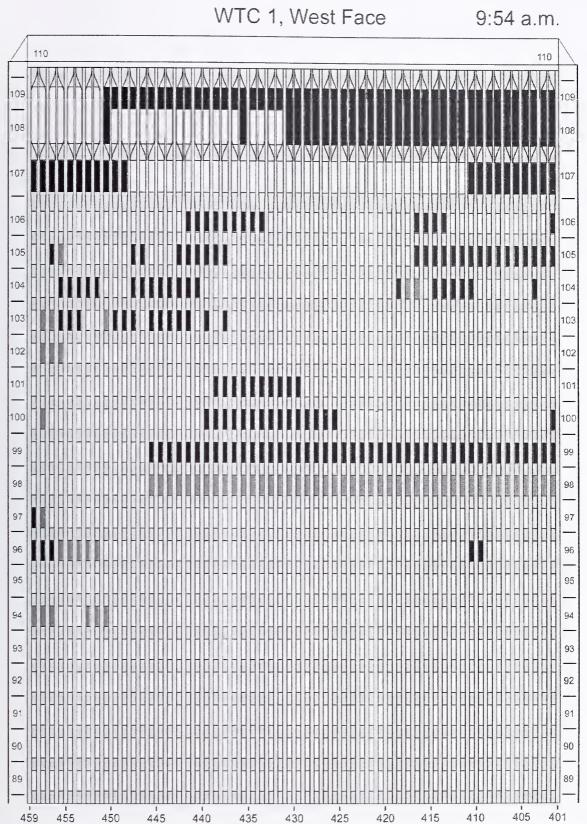
Figure F-48. Diagram of the west face of WTC 1 for floors 89 to 110 at 9:54 a.m. showing windows where smoke was observed and those that were hidden from view.

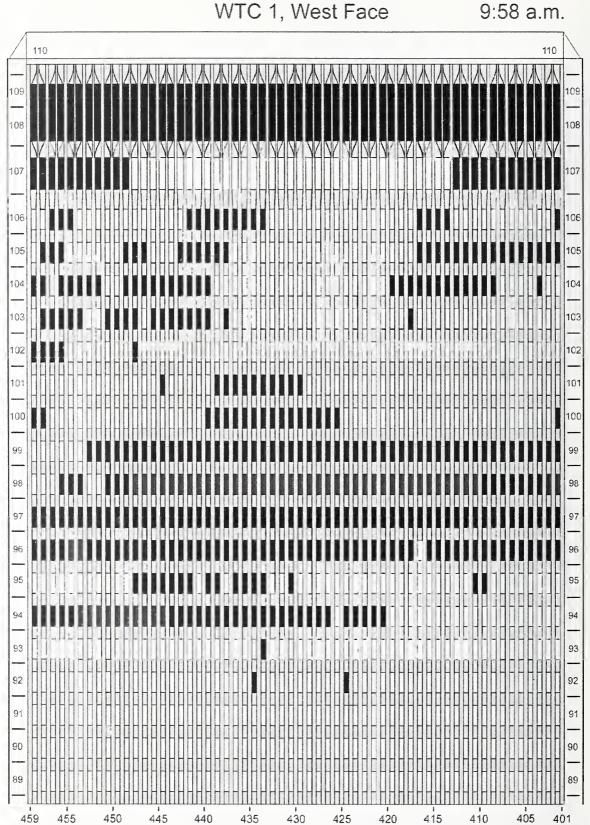
Figure F-49. Diagram of the west face of WTC 1 for floors 89 to 110 at 9:58 a.m. showing the condition of windows and locations of fires.

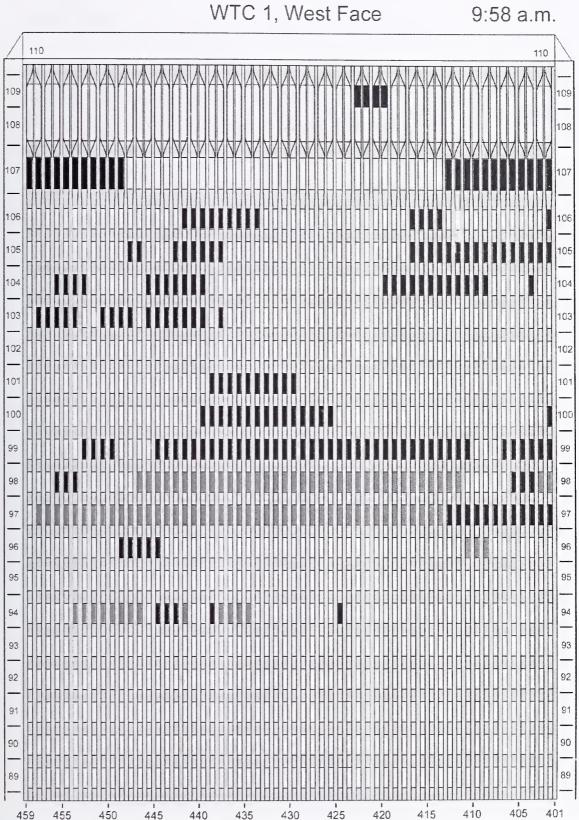
Figure F- 50. Diagram of the west face of WTC 1 for floors 89 to 110 at 9:58 a.m. showing windows where smoke was observed and those that were hidden from view.

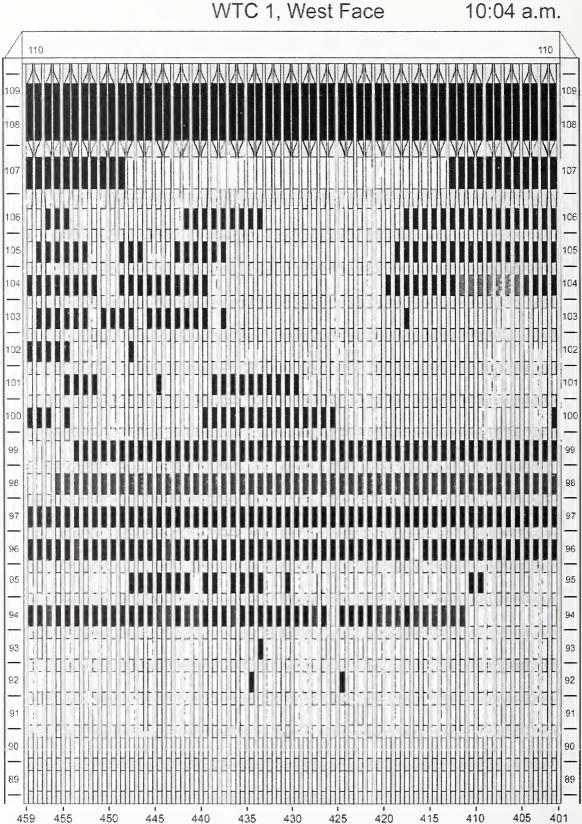
Figure F-51. Diagram of the west face of WTC 1 for floors 89 to 110 at 10:04 a.m. showing the condition of windows and locations of fires.

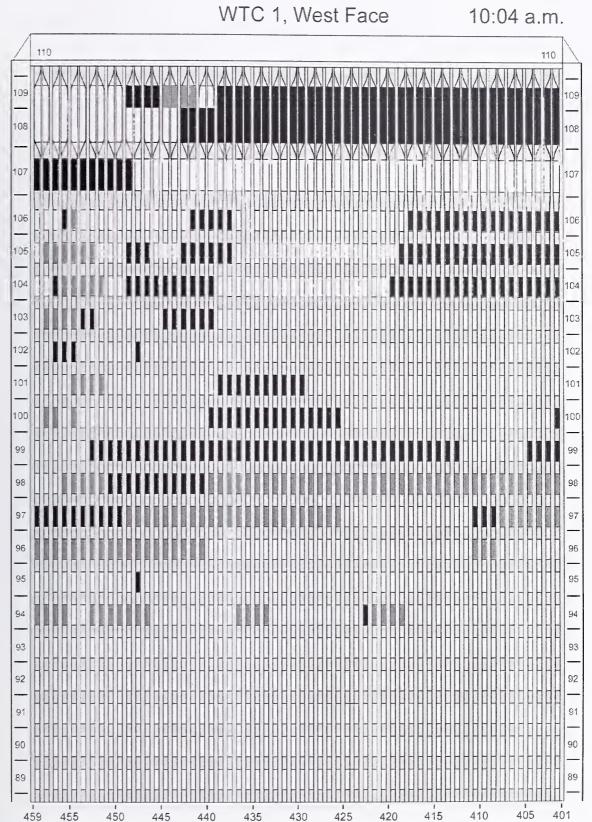
Figure F-52. Diagram of the west face of WTC 1 for floors 89 to 110 at 10:04 a.m. showing windows where smoke was observed and those that were hidden from view.

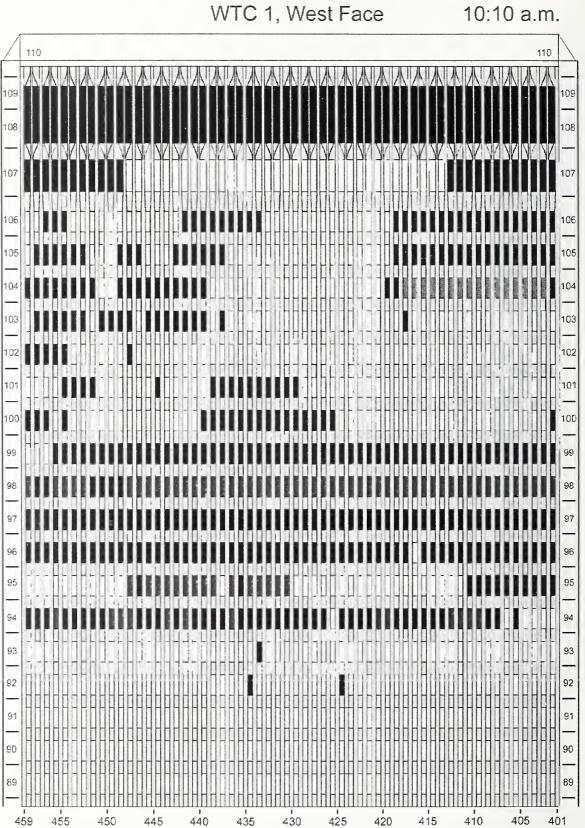
Figure F-53. Diagram of the west face of WTC 1 for floors 89 to 110 at 10:10 a.m. showing the condition of windows and locations of fires.

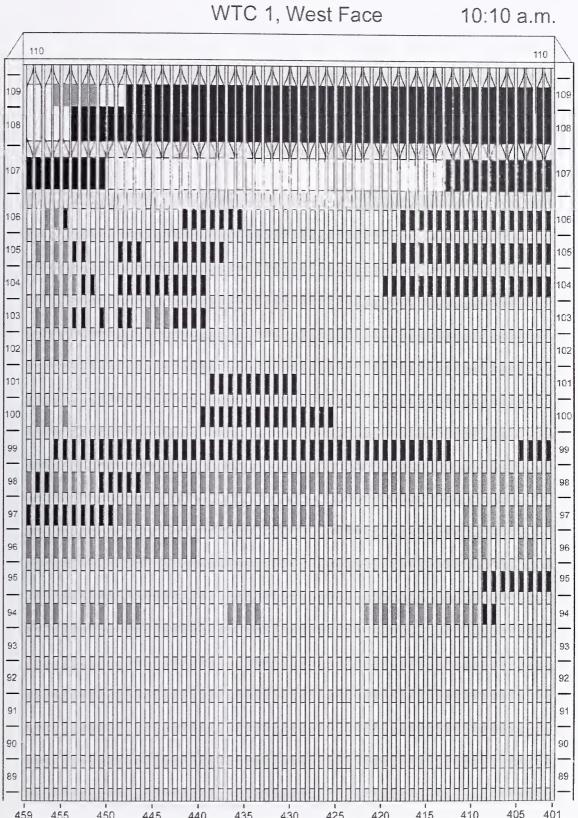
Figure F-54. Diagram of the west face of WTC 1 for floors 89 to 110 at 10:10 a.m. showing windows where smoke was observed and those that were hidden from view.

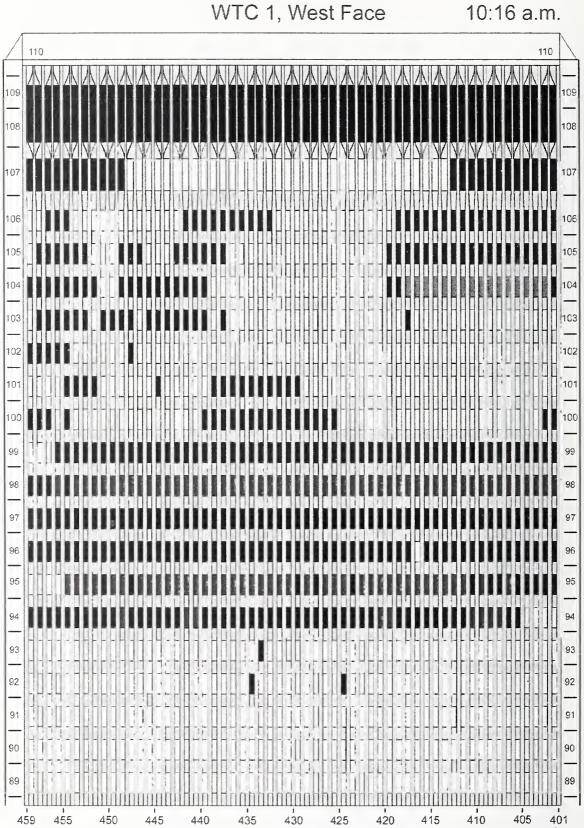
Figure F-55. Diagram of the west face of WTC 1 for floors 89 to 110 at 10:16 a.m. showing the condition of windows and locations of fires.

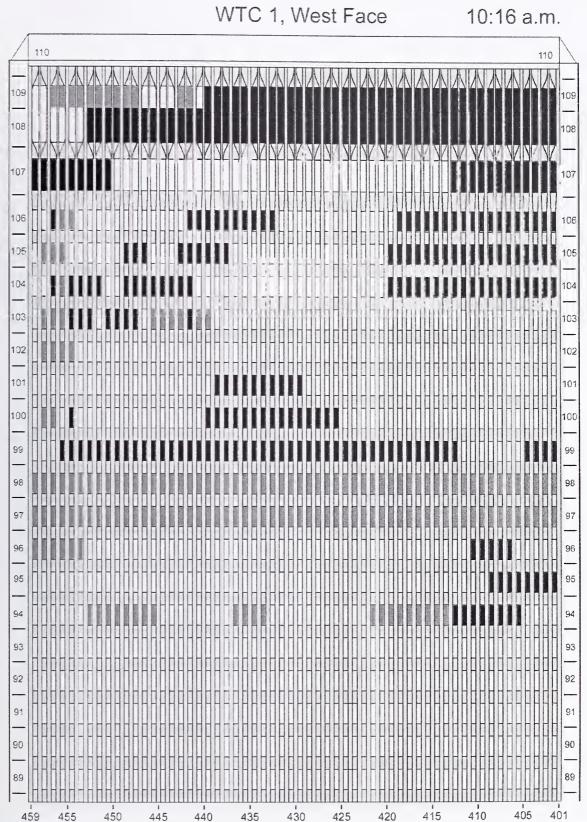
Figure F-56. Diagram of the west face of WTC 1 for floors 89 to 110 at 10:16 a.m. showing windows where smoke was observed and those that were hidden from view.

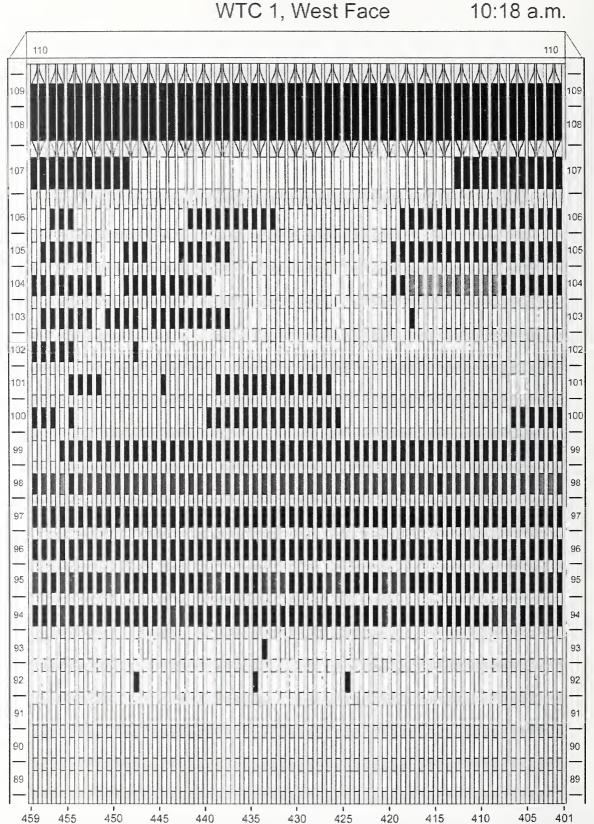
Figure F-57. Diagram of the west face of WTC 1 for floors 89 to 110 at 10:18 a.m. showing the condition of windows and locations of fires.

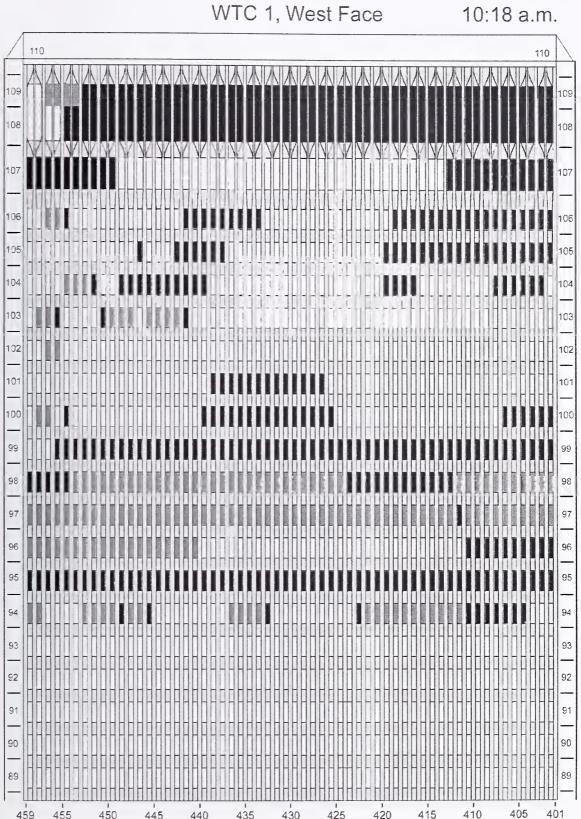
Figure F-58. Diagram of the west face of WTC 1 for floors 89 to 110 at 10:18 a.m. showing windows where smoke was observed and those that were hidden from view.

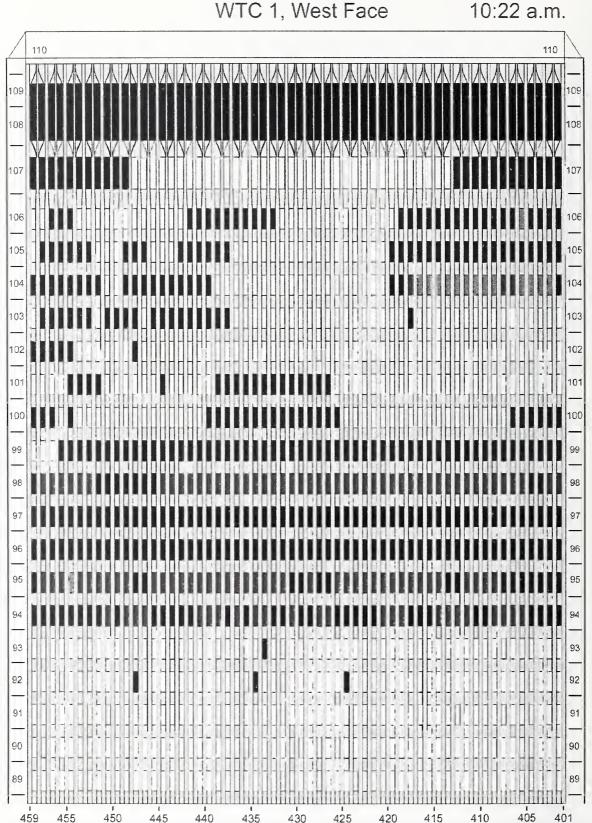
Figure F-59. Diagram of the west face of WTC 1 for floors 89 to 110 at 10:22 a.m. showing the condition of windows and locations of fires.

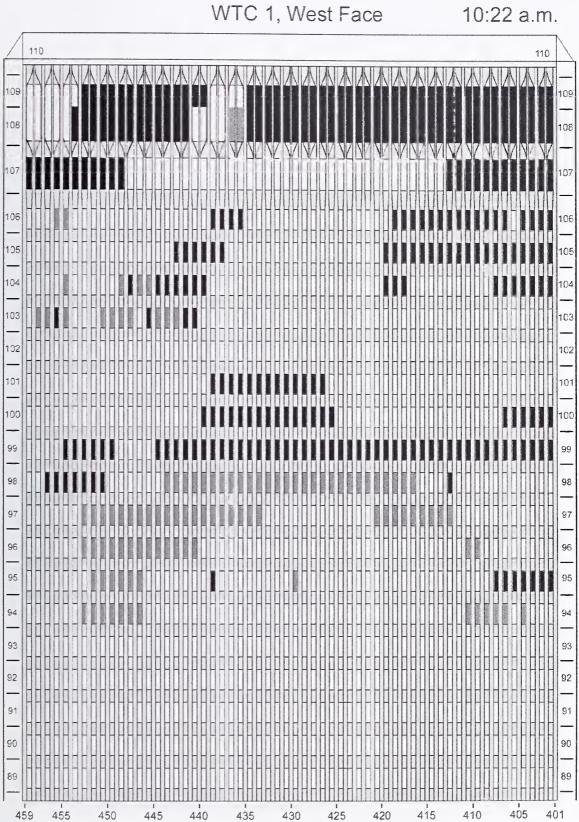
Figure F-60. Diagram of the west face of WTC 1 for floors 89 to 110 at 10:22 a.m. showing windows where smoke was observed and those that were hidden from view.

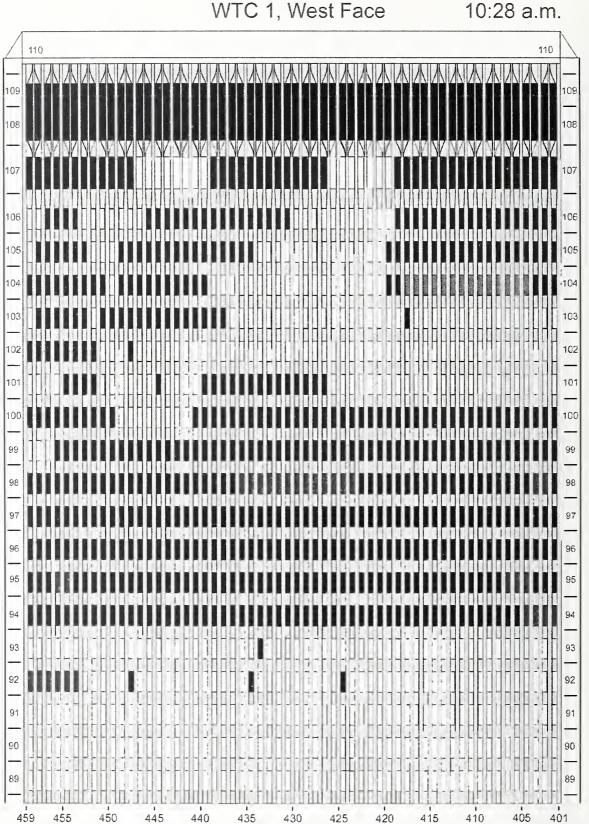
Figure F-61. Diagram of the west face of WTC 1 for floors 89 to 110 at 10:28 a.m. showing the condition of windows and locations of fires.

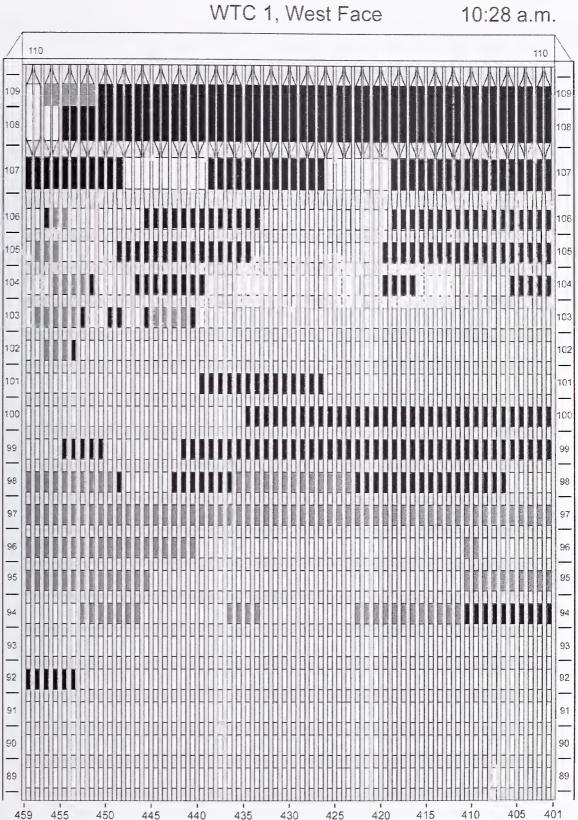
Figure F-62. Diagram of the west face of WTC 1 for floors 89 to 110 at 10:28 a.m. showing windows where smoke was observed and those that were hidden from view.

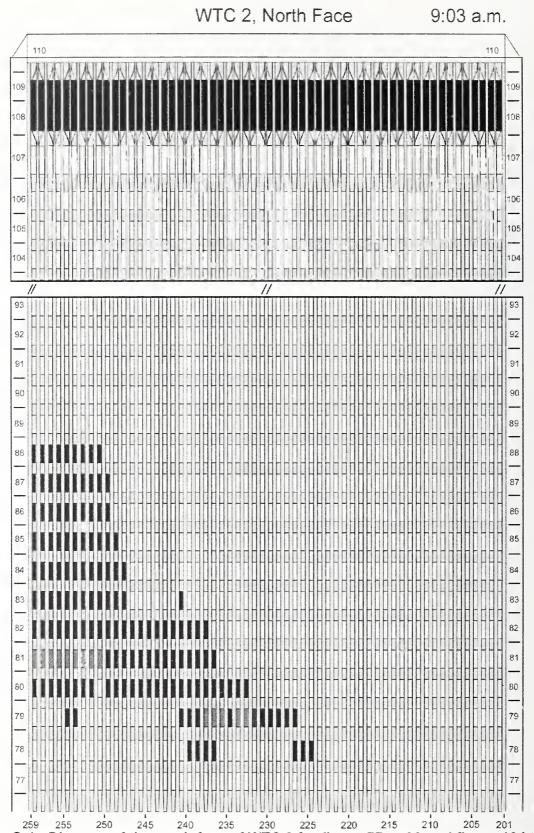
Figure G-1. Diagram of the north face of WTC 2 for floors 77 to 93 and floors 104 to 110 at 9:03 a.m. showing the condition of windows and locations of fires.

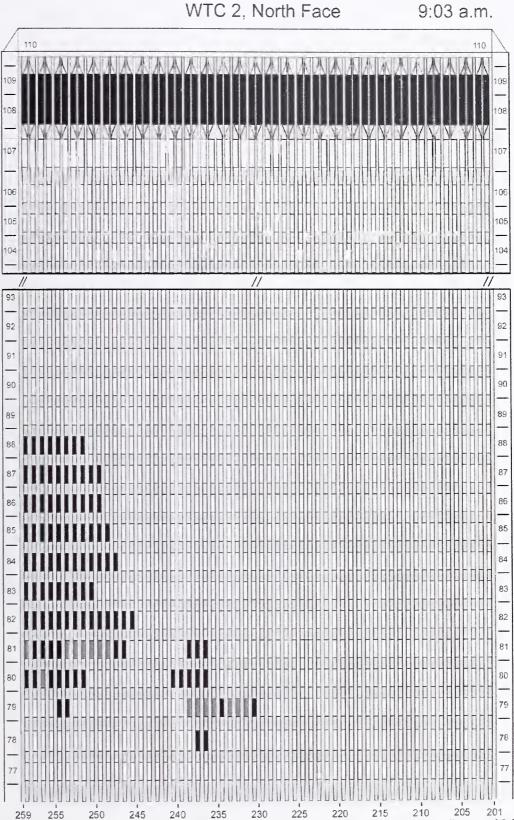
Figure G-2. Diagram of the north face of WTC 2 for floors 77 to 93 and floors 104 to 110 at 9:03 a.m. showing windows where smoke was observed and those hidden from view.

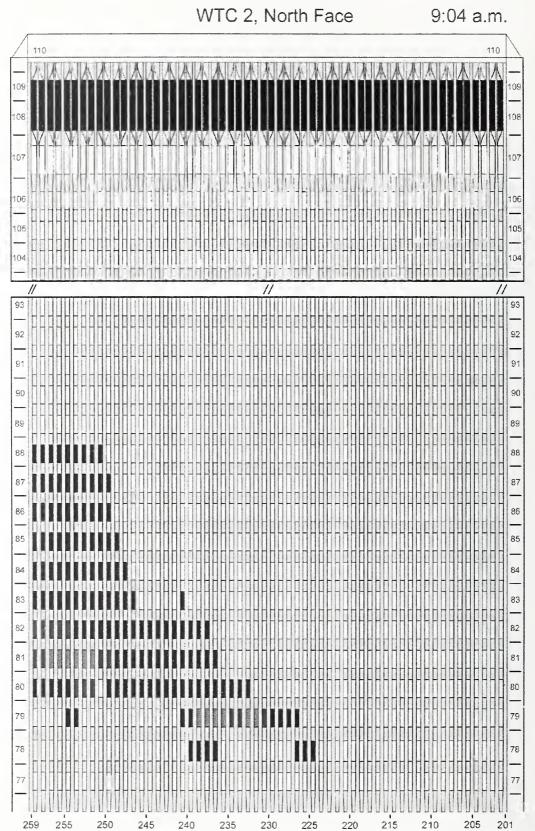
Figure G-3. Diagram of the north face of WTC 2 for floors 77 to 93 and floors 104 to 110 at 9:04 a.m. showing the condition of windows and locations of fires.

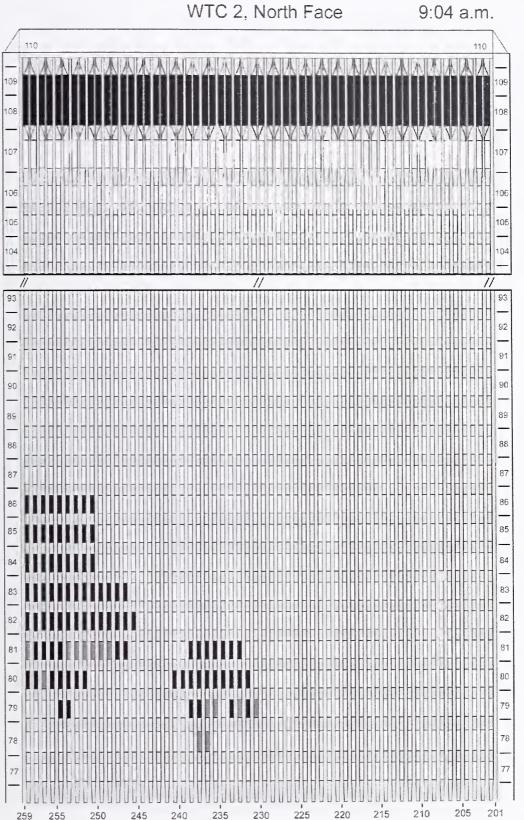
Figure G-4. Diagram of the north face of WTC 2 for floors 77 to 93 and floors 104 to 110 at 9:04 a.m. showing windows where smoke was observed and those hidden from view.

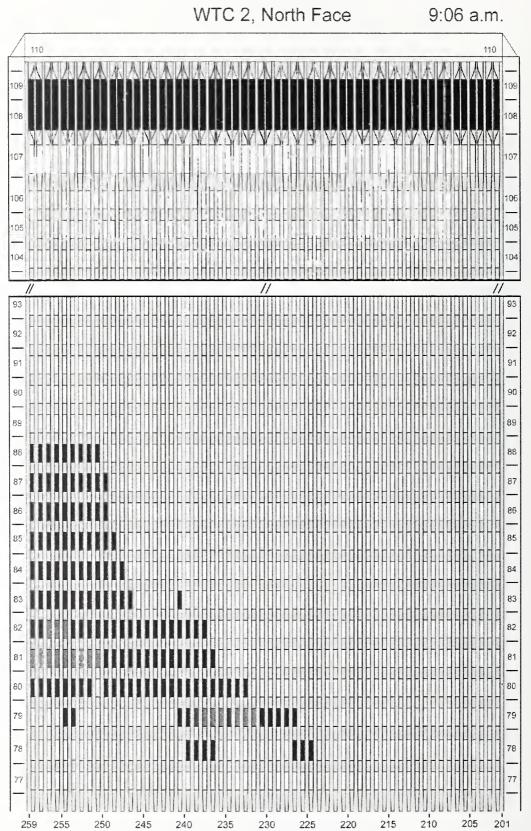
Figure G-5. Diagram of the north face of WTC 2 for floors 77 to 93 and floors 104 to 110 at 9:06 a.m. showing the condition of windows and locations of fires.

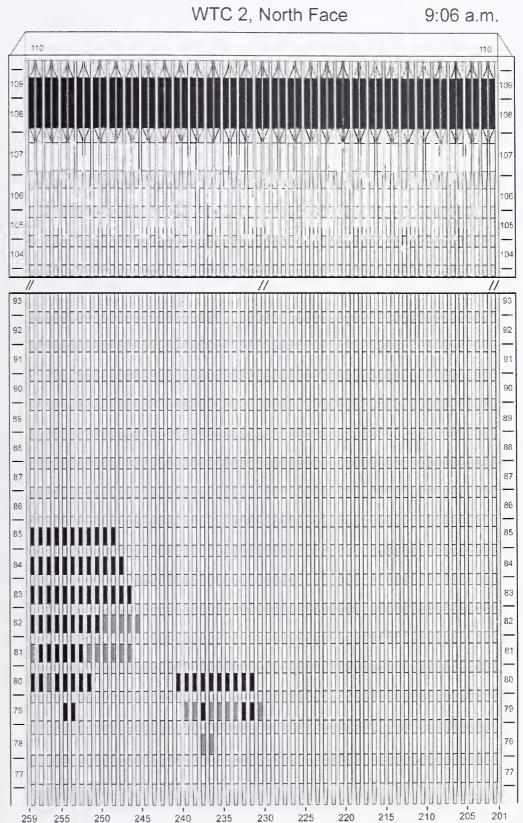
Figure G-6. Diagram of the north face of WTC 2 for floors 77 to 93 and floors 104 to 110 at 9:06 a.m. showing windows where smoke was observed and those hidden from view.

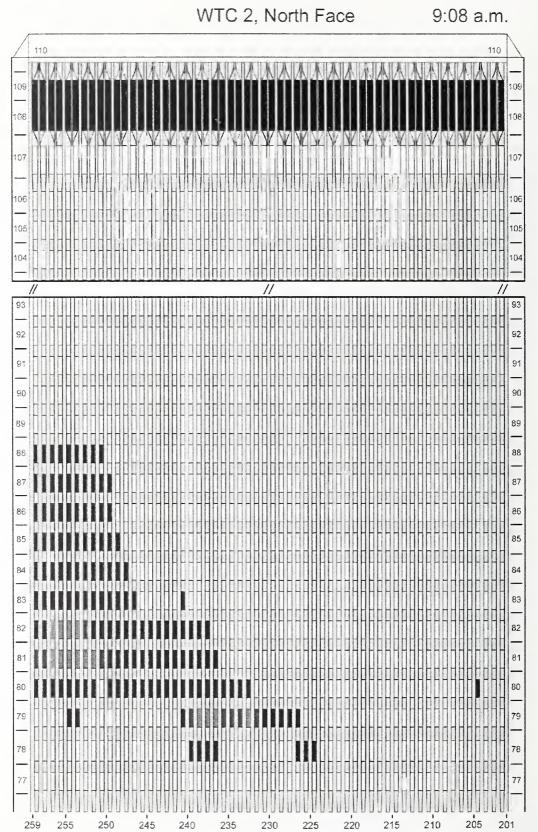
Figure G-7. Diagram of the north face of WTC 2 for floors 77 to 93 and floors 104 to 110 at 9:08 a.m. showing the condition of windows and locations of fires.

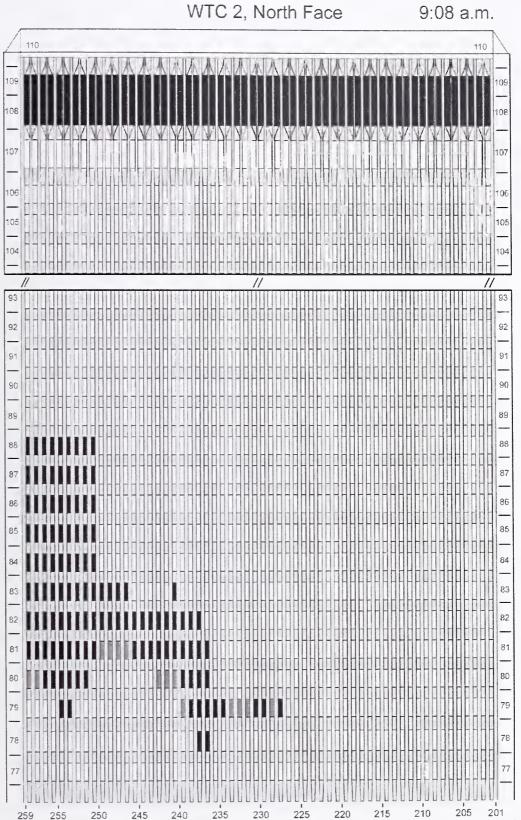
Figure G-8. Diagram of the north face of WTC 2 for floors 77 to 93 and floors 104 to 110 at 9:08 a.m. showing windows where smoke was observed and those hidden from view.

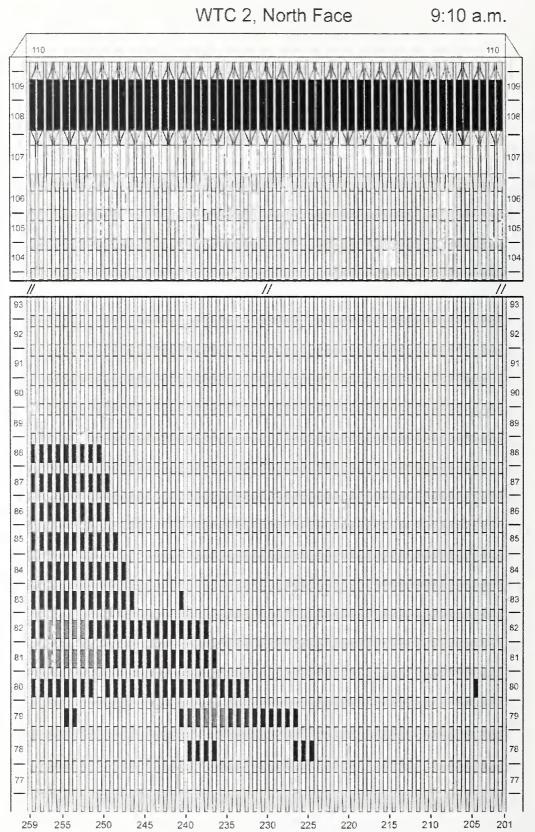
Figure G-9. Diagram of the north face of WTC 2 for floors 77 to 93 and floors 104 to 110 at 9:10 a.m. showing the condition of windows and locations of fires.

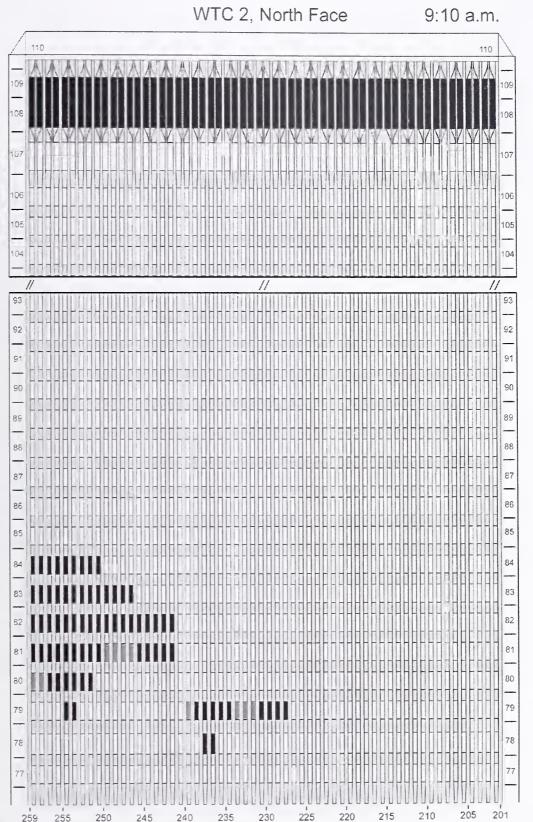
Figure G-10. Diagram of the north face of WTC 2 for floors 77 to 93 and floors 104 to 110 at 9:10 a.m. showing windows where smoke was observed and those hidden from view.

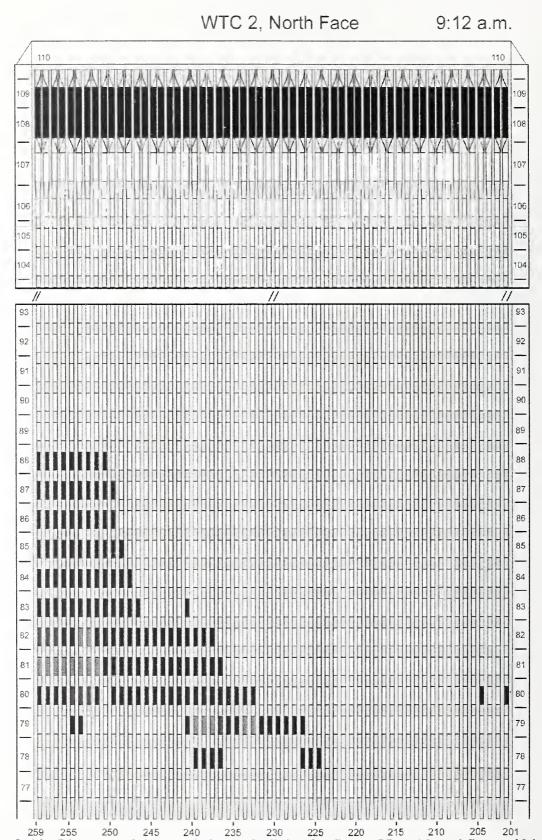
Figure G-11. Diagram of the north face of WTC 2 for floors 77 to 93 and floors 104 to 110 at 9:12 a.m. showing the condition of windows and locations of fires.

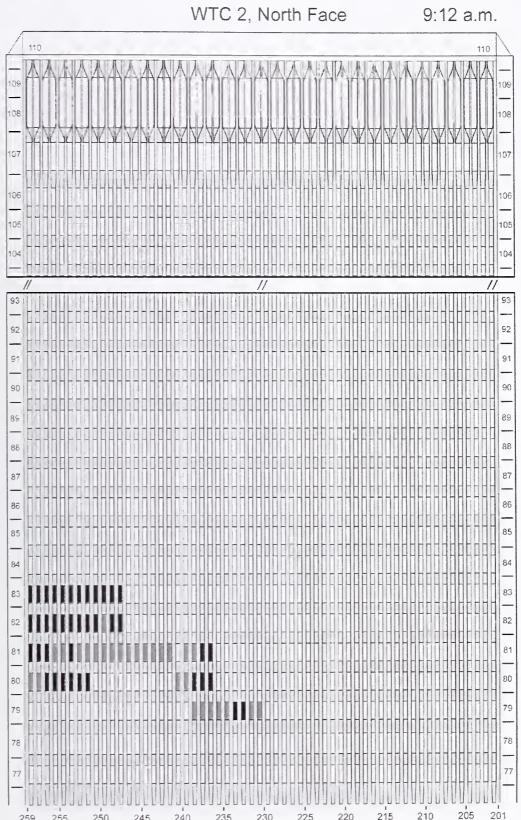
Figure G-12. Diagram of the north face of WTC 2 for floors 77 to 93 and floors 104 to 110 at 9:12 a.m. showing windows where smoke was observed and those hidden from view.

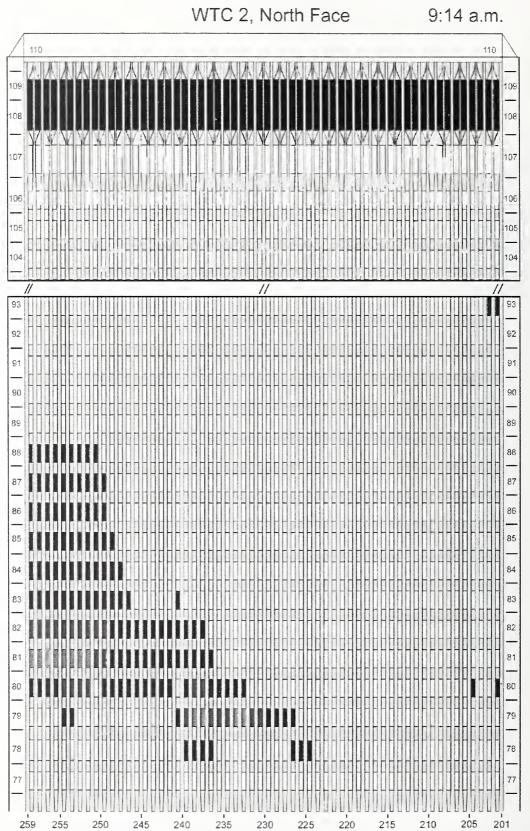
Figure G-13. Diagram of the north face of WTC 2 for floors 77 to 93 and floors 104 to 110 at 9:14 a.m. showing the condition of windows and locations of fires.

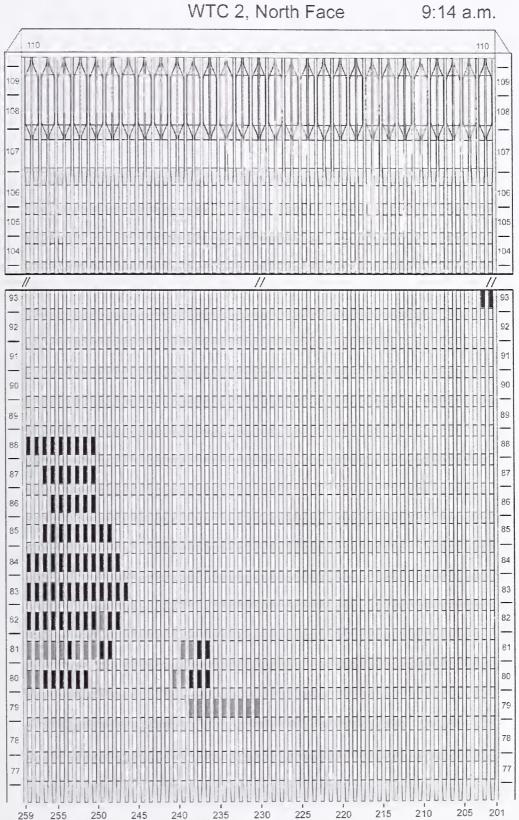
Figure G-14. Diagram of the north face of WTC 2 for floors 77 to 93 and floors 104 to 110 at 9:14 a.m. showing windows where smoke was observed and those hidden from view.

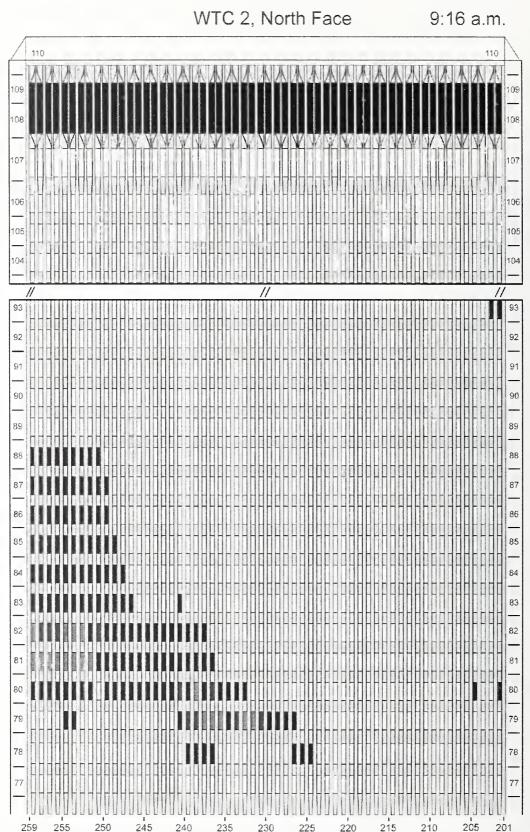
Figure G-15. Diagram of the north face of WTC 2 for floors 77 to 93 and floors 104 to 110 at 9:16 a.m. showing the condition of windows and locations of fires.

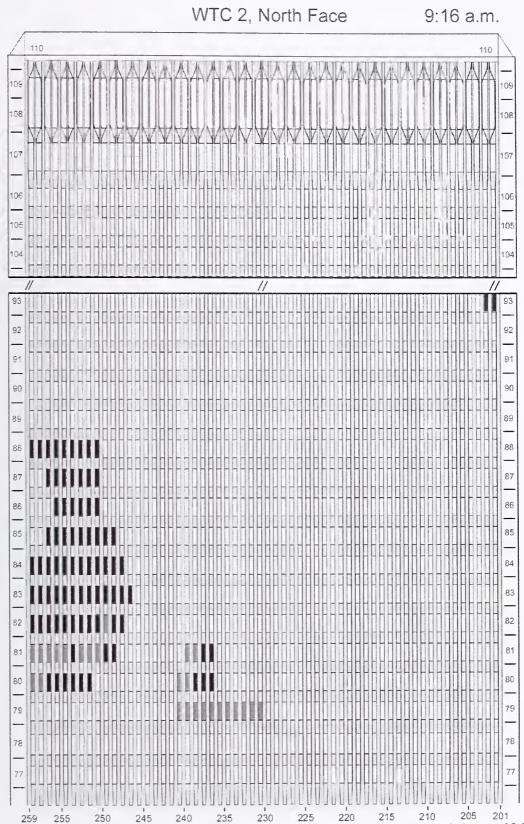
Figure G-16. Diagram of the north face of WTC 2 for floors 77 to 93 and floors 104 to 110 at 9:16 a.m. showing windows where smoke was observed and those hidden from view.

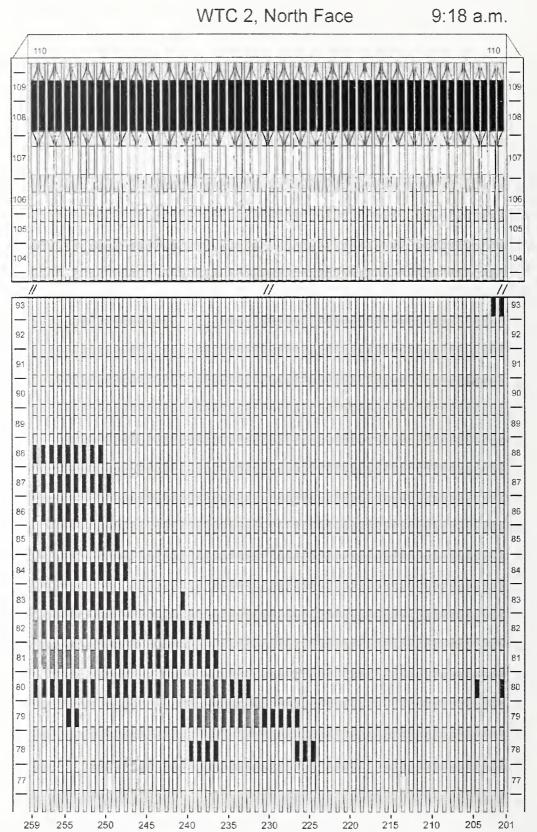
Figure G-17. Diagram of the north face of WTC 2 for floors 77 to 93 and floors 104 to 110 at 9:18 a.m. showing the condition of windows and locations of fires.

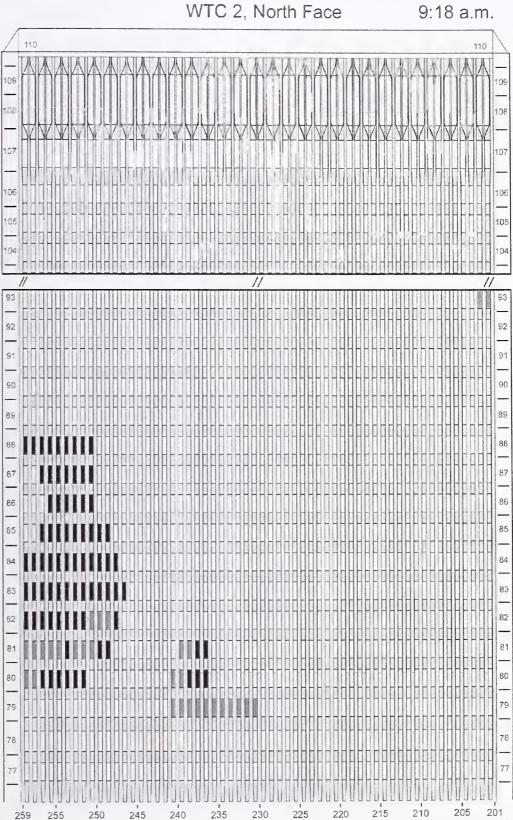
Figure G-18. Diagram of the north face of WTC 2 for floors 77 to 93 and floors 104 to 110 at 9:18 a.m. showing windows where smoke was observed and those hidden from view.

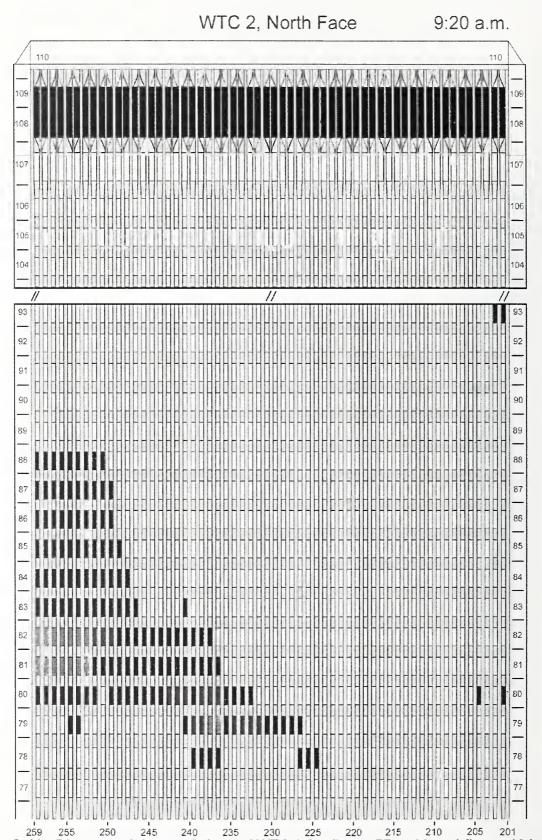
Figure G-19. Diagram of the north face of WTC 2 for floors 77 to 93 and floors 104 to 110 at 9:20 a.m. showing the condition of windows and locations of fires.

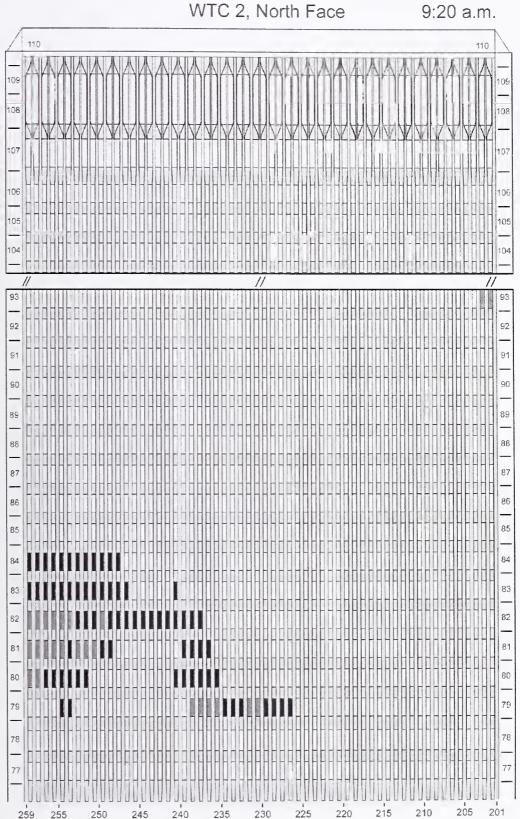
Figure G-20. Diagram of the north face of WTC 2 for floors 77 to 93 and floors 104 to 110 at 9:20 a.m. showing windows where smoke was observed and those hidden from view.

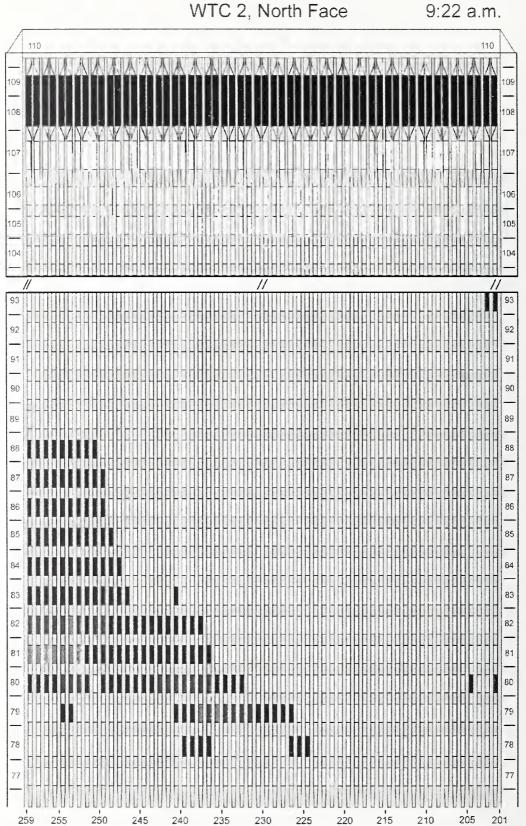
Figure G-21. Diagram of the north face of WTC 2 for floors 77 to 93 and floors 104 to 110 at 9:22 a.m. showing the condition of windows and locations of fires.

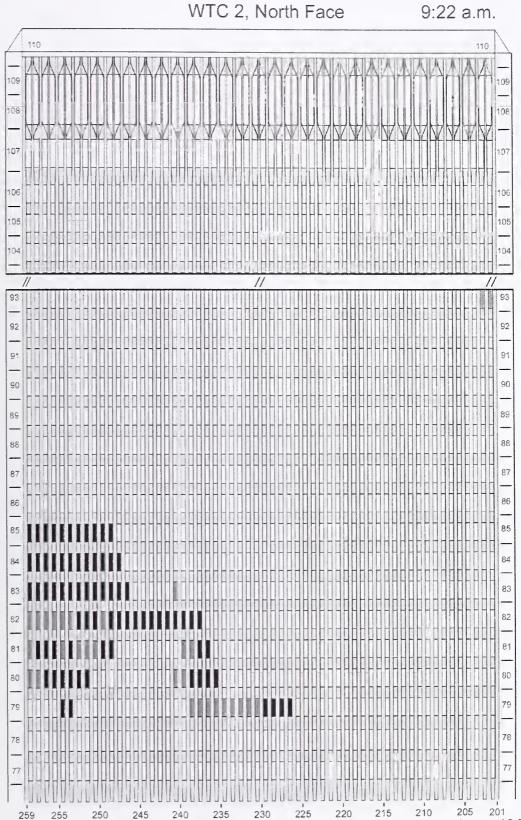
Figure G-22. Diagram of the north face of WTC 2 for floors 77 to 93 and floors 104 to 110 at 9:22 a.m. showing windows where smoke was observed and those hidden from view.

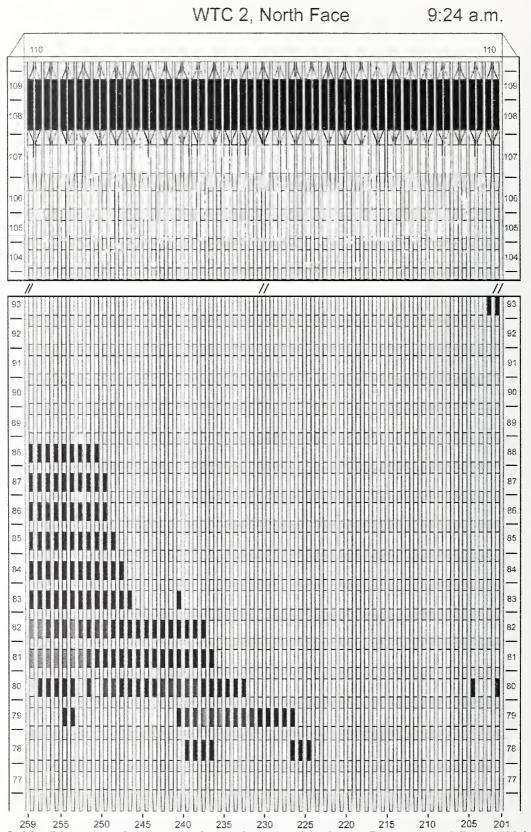
Figure G-23. Diagram of the north face of WTC 2 for floors 77 to 93 and floors 104 to 110 at 9:24 a.m. showing the condition of windows and locations of fires.
